# *Office of River Protection*

## *S-102 Briefing to the Oregon Hanford Cleanup Board*

Shirley J. Olinger  
Acting Manager  
October 9, 2007

# S-102 Event Site Overview

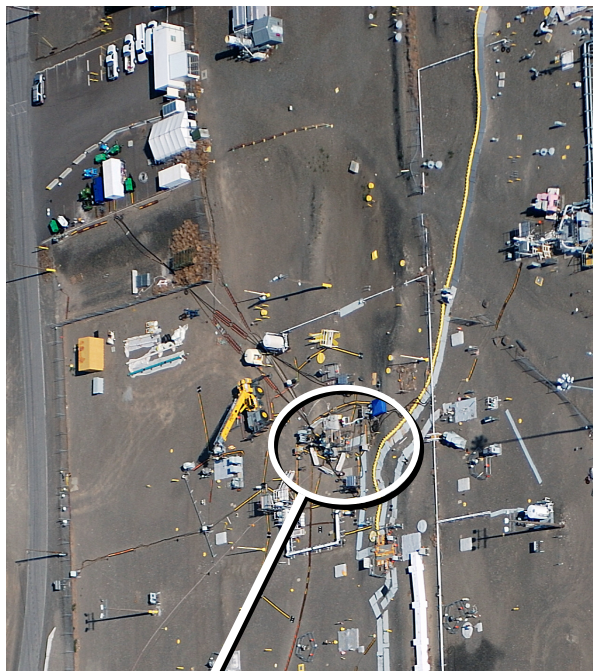
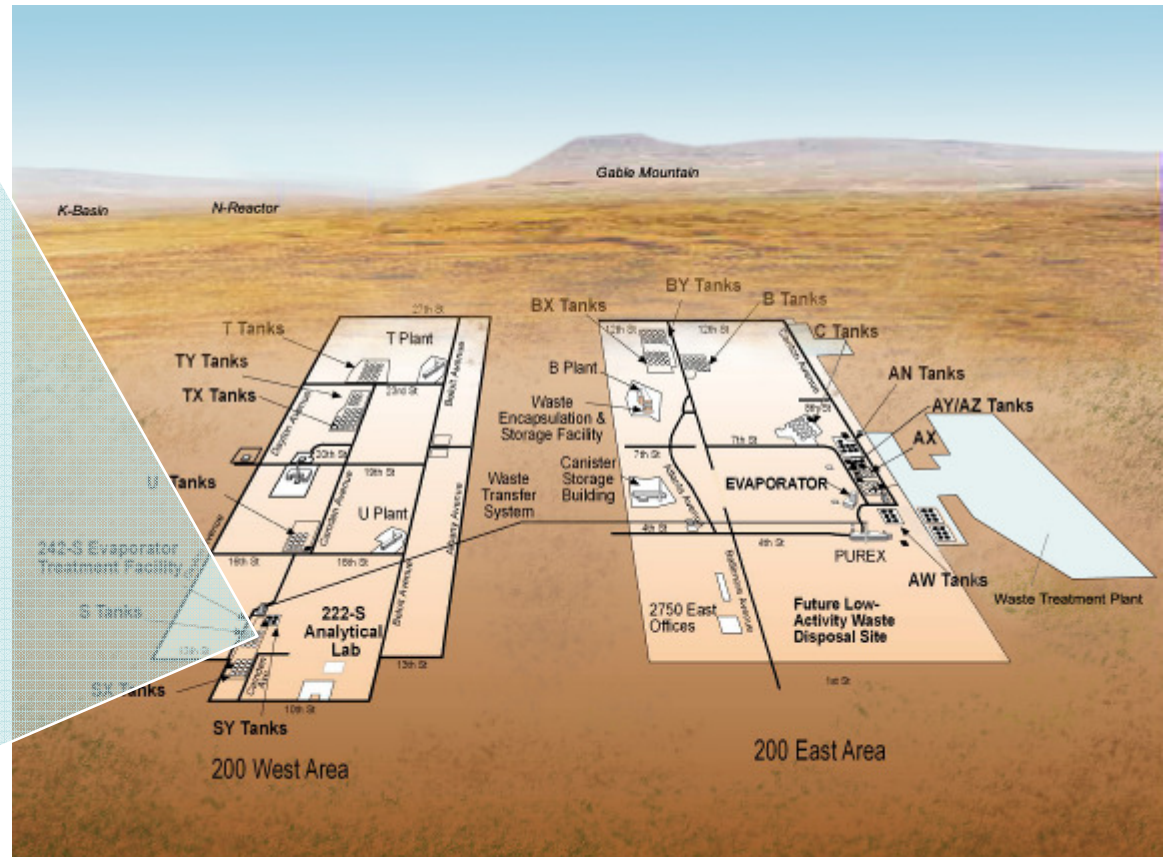
S-Farm

S-102

200 Area Tank Farms

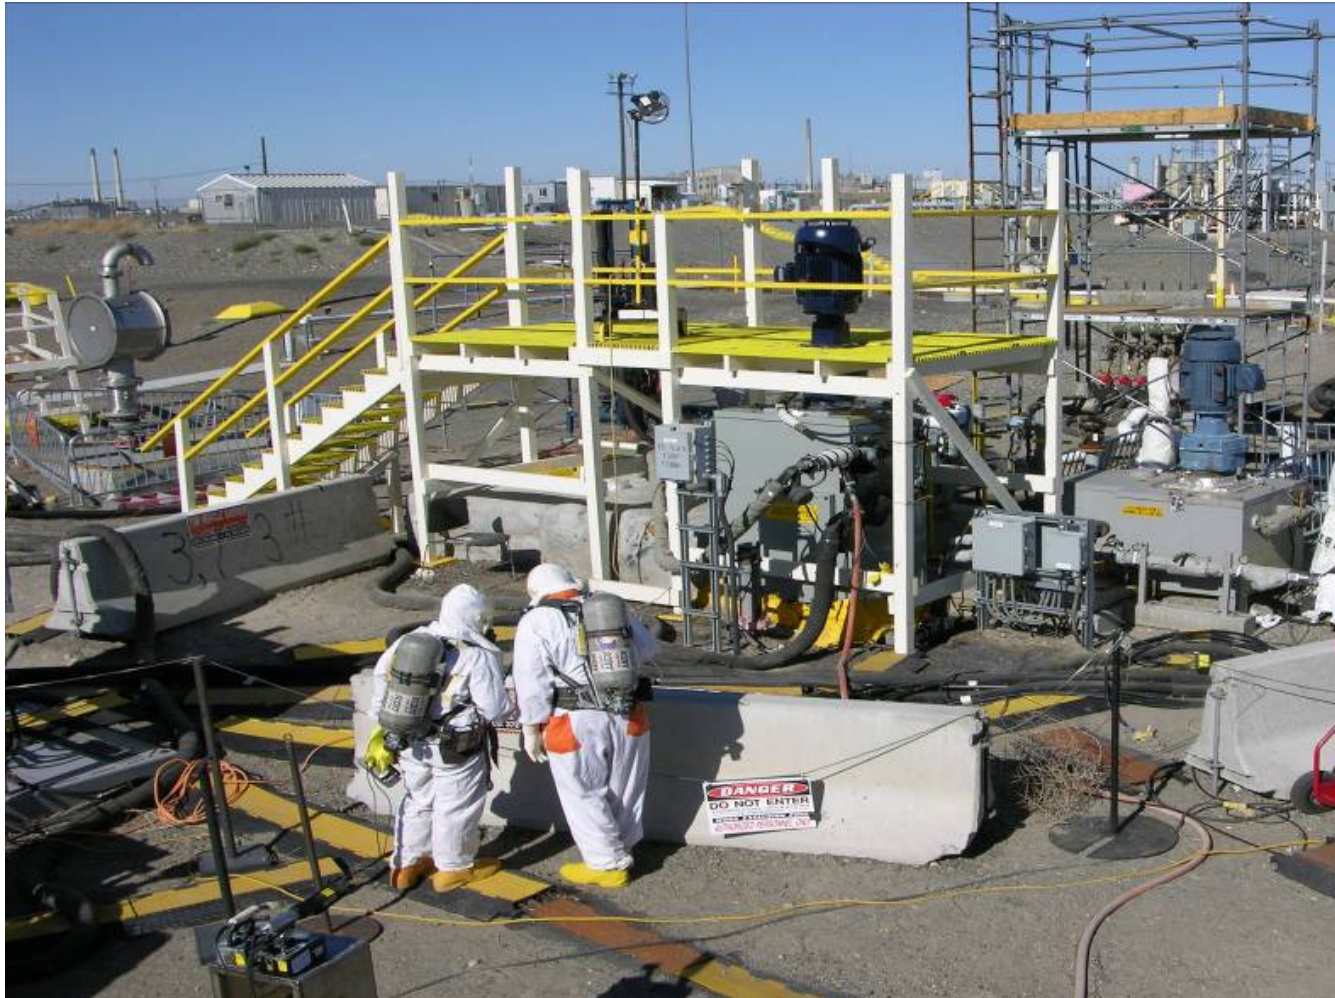
## *Spill Area*

- Splash pattern consistent with release near dilution hose near NW corner of pump pit
  - On jersey barrier
  - On chair
  - On stairs
  - Not on wood platform, top of pump box, top of pump pit

- Sparge hose not in vicinity of source of spray pattern
- Spill pool consistent with near surface release
  - Bathtub ring along north side of pump pit between pit and dilution hose

- Spill area stabilized (Soil Segment and Safeguard)
- Spill area surrounded by locked fence
  - Postings for: high radiation, high contamination, respiratory protection required for entry
- Spill area monitored for potential spread of contamination
  - Surveys every four hours at high radiation/high contamination area boundary
  - Weekly samples inside the fenced area including contamination and dose rate surveys
- Industrial Hygiene monitoring

- Maintain control of contamination within HRA/HA
- Reduction of the source term
- Remove above ground equipment
- Excavate/remove contaminated soil
- Remove miscellaneous equipment and decontaminate permanent equipment
- Backfill with clean soil
- Perform final condition assessment

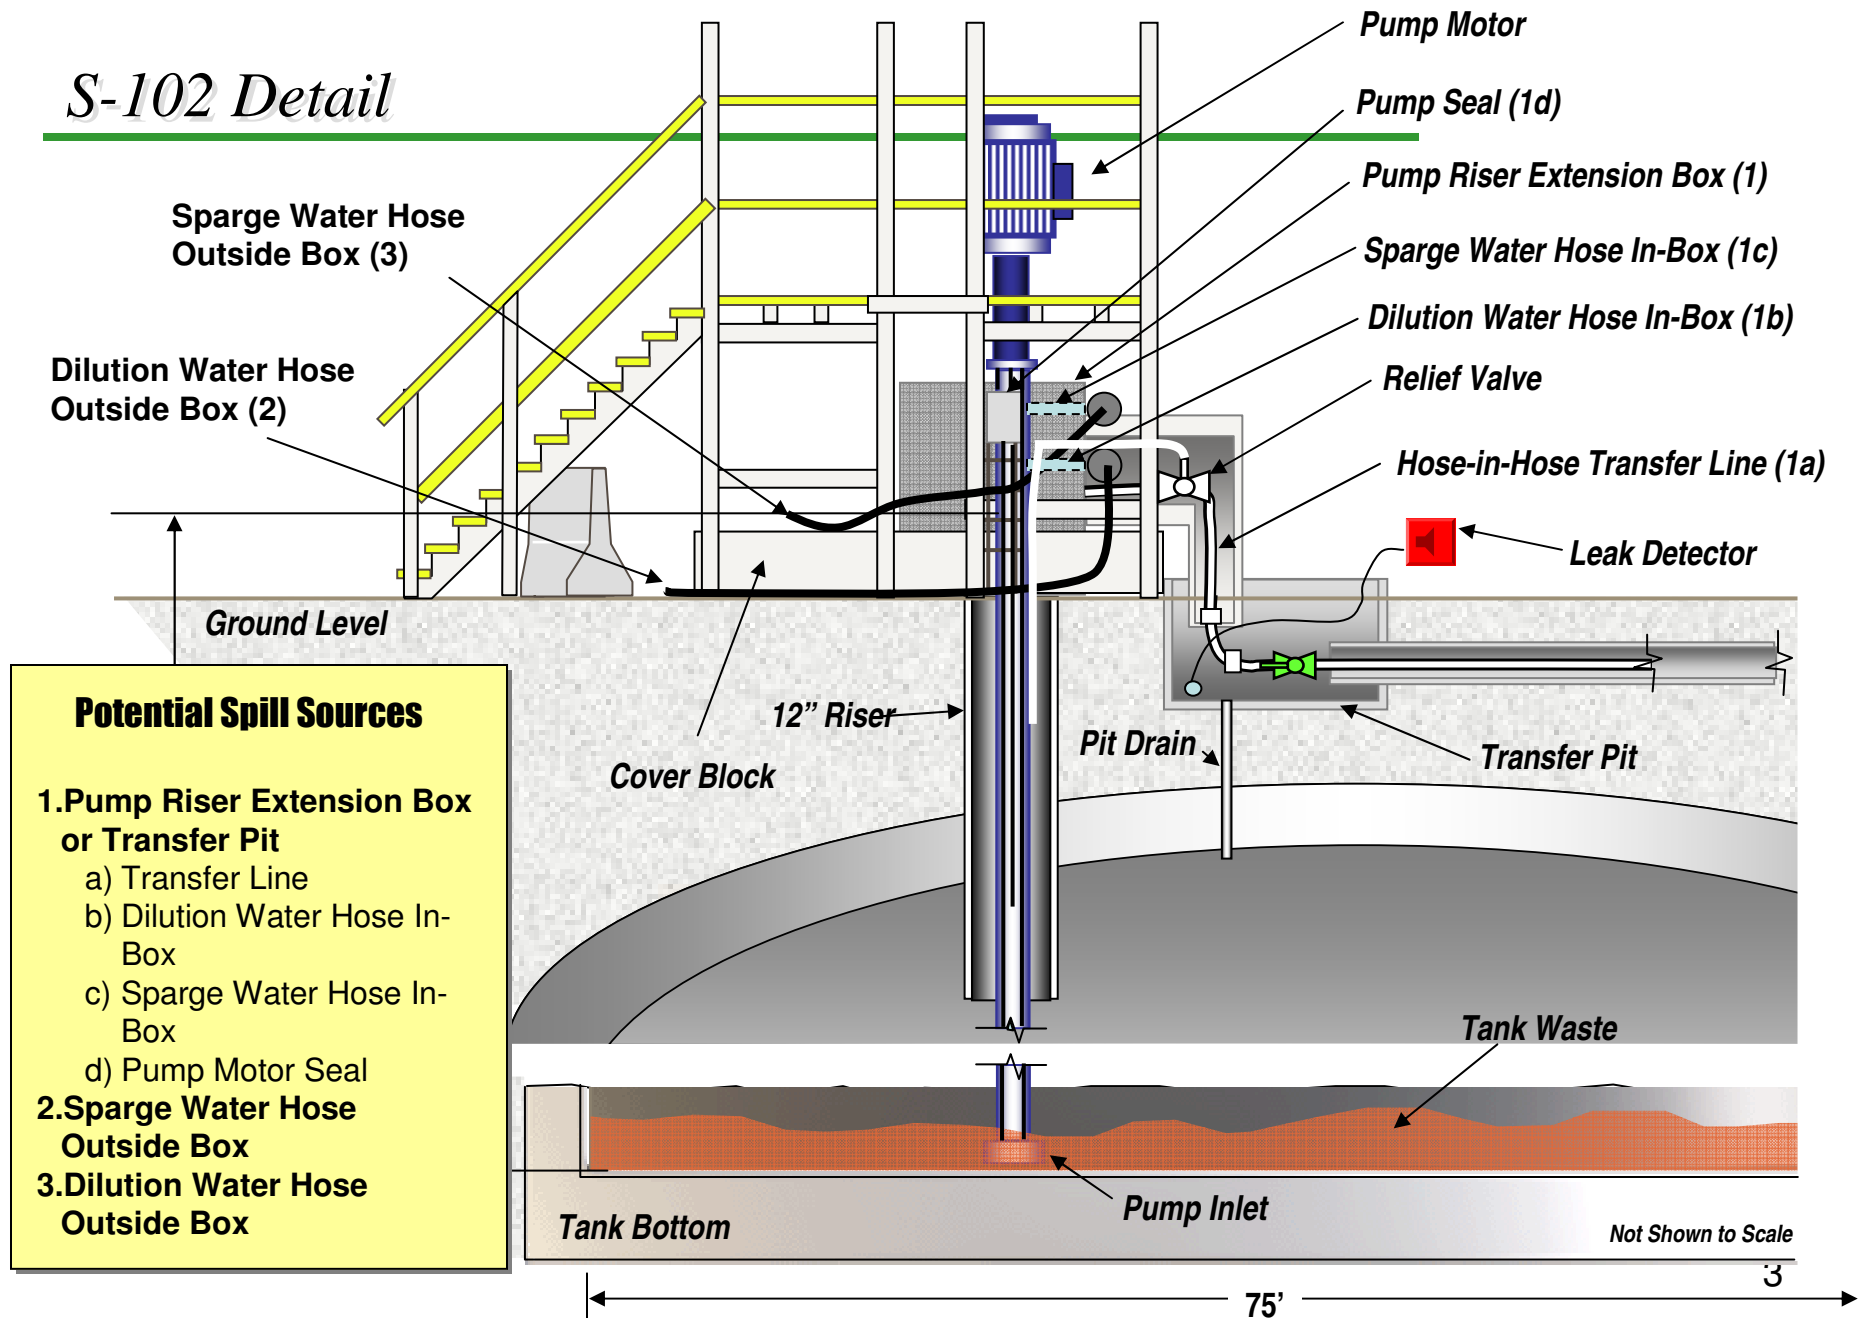
## S-102 Detail

- Spill occurred between 2:05 and 2:20 AM while pump was operated in reverse direction
  - Personnel, including HPT, out of field during this time. Would have noticed splash before that time

- Abnormal readings after that time
  - Pressure in transfer system measured at static head from SY-102 until 20 seconds into last reverse pump run, when it went to zero (air bubble coming down from SY-102 anti-siphon)

- No discoloration near release points from pit or pump box
- Radiation reading consistent with dilution hose
  - Higher readings where hose is off ground, out of spill

- Sparge hose readings at background where off ground, out of spill
- Transfer pit and pump box unlikely sources of spill
  - Pump box drains into transfer pit OR into the tank

- Leak detector in transfer pit
  - Transfer pit drains to tank
  - Transfer pit is below grade with a void volume of over 1,500 gallons

- The direct cause was leakage of waste from the retrieval pump system in S-102, due to the failure of a utility hose in the dilution line as a result of overpressure

- The root cause was the pump system did not have mechanism to prevent backflow and the subsequent over pressurization of the hose, although required
- Judgment of needs include:

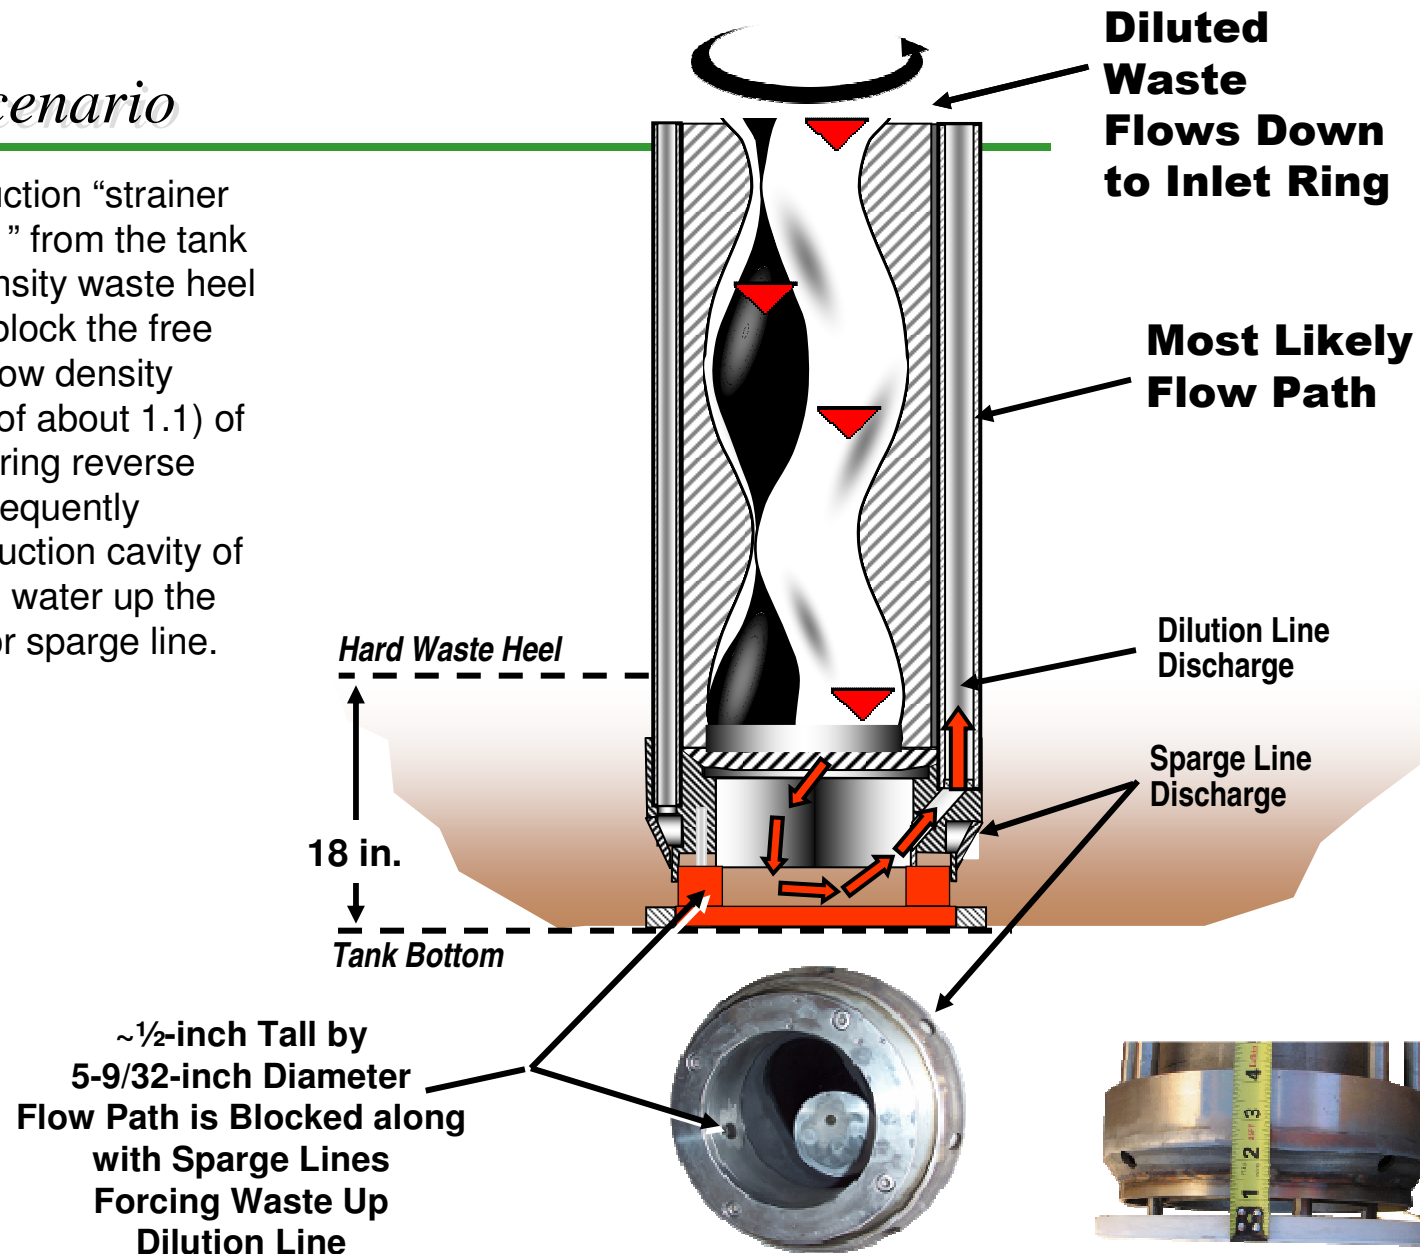
*Bottom and Side-View Photo of Pump Inlet*

With the pump suction “strainer plate” within  $\frac{1}{2}$  - 1” from the tank floor, the high density waste heel was sufficient to block the free flow of relatively low density (Specific Gravity of about 1.1) of transfer waste during reverse rotation and subsequently pressurized the suction cavity of the pump, forcing water up the dilution line and/or sparge line.

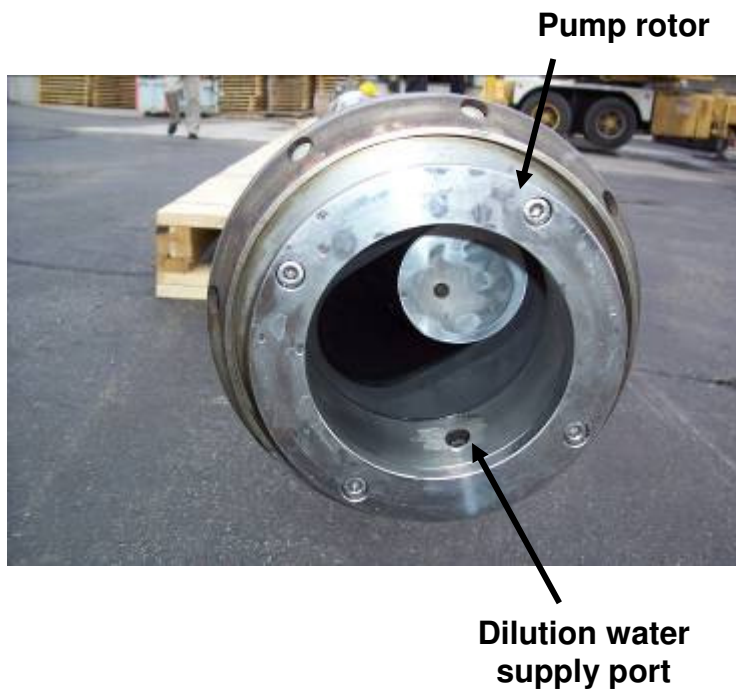
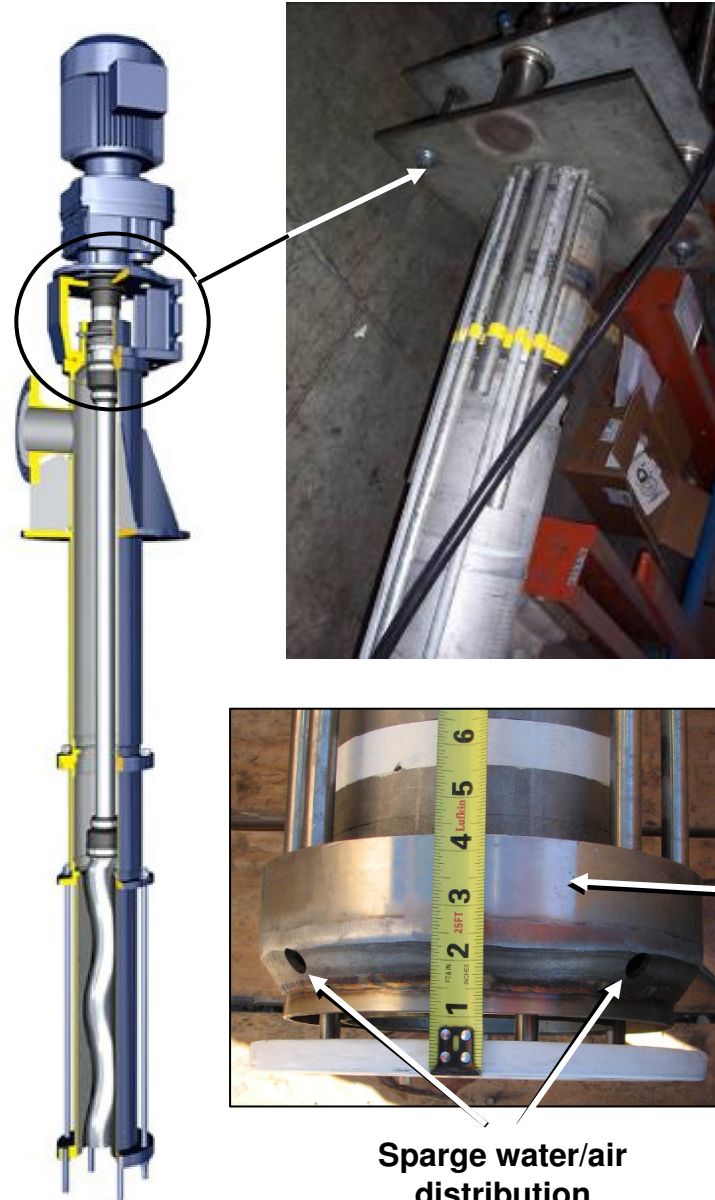
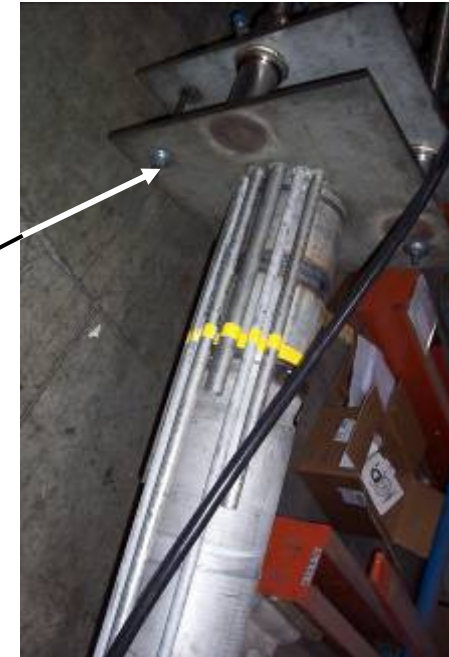
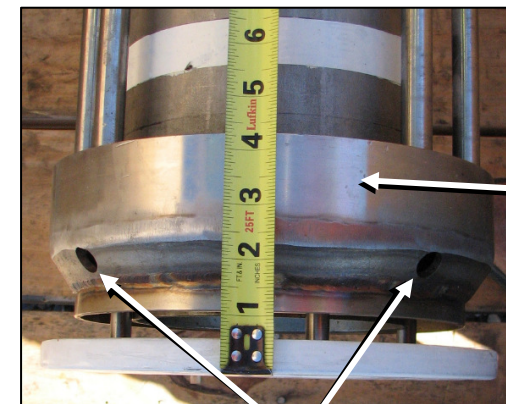
## *Pump Inlet Nozzle*

Sparge  
ring

Sparge water/air  
distribution  
ports
